5.4 BUILDING INNOVATIONS

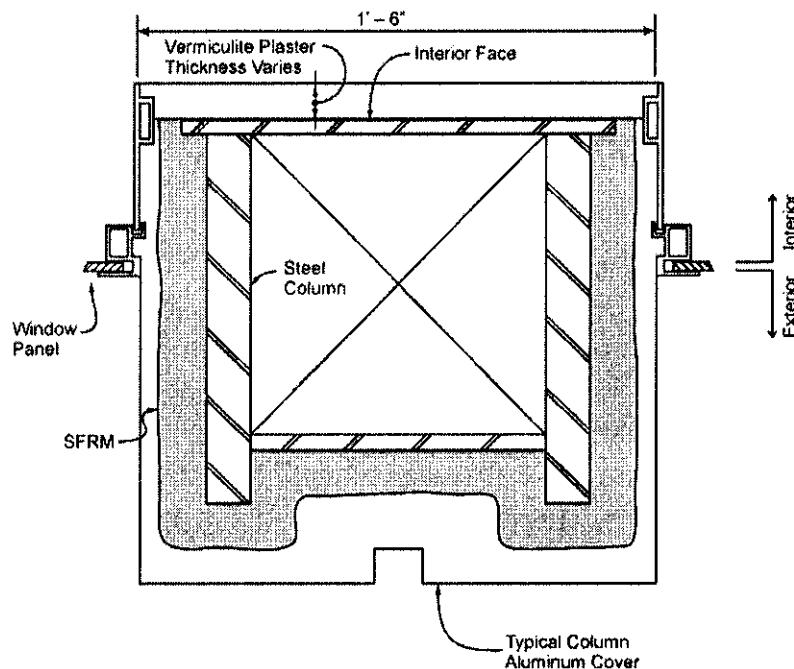
Figure 5–6. Thermal insulation for perimeter columns.

In 1966, the contractor responsible for insulating the perimeter columns proposed applying a 1 3/16 in. thick coating of BLAZE-SHIELD D to the three external faces (Figure 5–6) to achieve a 4 hour rating, which is a Class 1A rating requirement (1 hour more than Class 1B). NIST found evidence of a technical basis for this decision. In the construction drawings prepared by the exterior cladding contractor, the following SFRM thicknesses were specified:

- 7/8 in. of vermiculite plaster on the interior face and 1 3/16 in. of BLAZE-SHIELD D on the other three faces.
- 1/2 in. of vermiculite plaster on the interior surfaces of the spandrels and 1/2 in. of BLAZE-SHIELD D on the exterior surfaces.

Vermiculite plaster had a higher thermal conductivity and thereby increased heat migration from the room air to the column steel and, thus, could keep the steel temperature at 70 °F when the temperature was 0 °F outside.

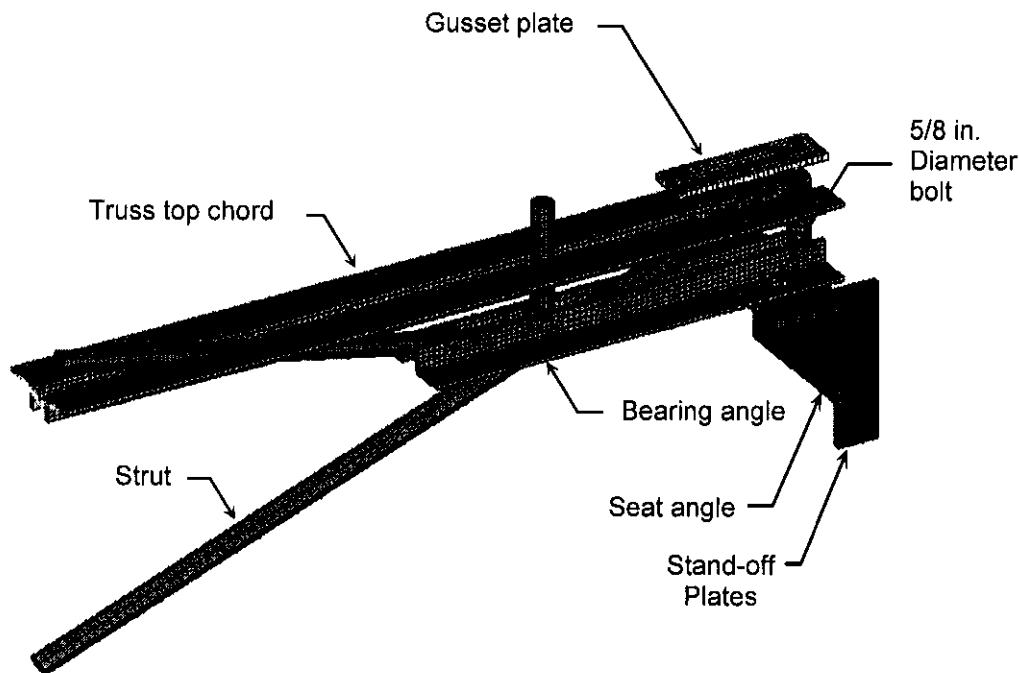
Figure 6-10. Finite element model of an exterior truss seat.

- **Truss seats.** Figure 6–10 shows how an exterior seat connection was represented in the finite element structural model. The component analysis determined that failure could occur at the bolted connection between the bearing angle and the seat angle, and the truss could slip off the seat. Truss seat connection failure from vertical loads was found to be unlikely, since the needed increase in vertical load was unreasonable for temperatures near 600 °C to 700 °C.
- **Knuckles.** The “knuckle” was formed by the extension of the truss diagonals into the concrete slab and provided for composite action of the steel truss and concrete slab. A model was developed to predict the knuckle performance when the truss and concrete slab acted compositely.

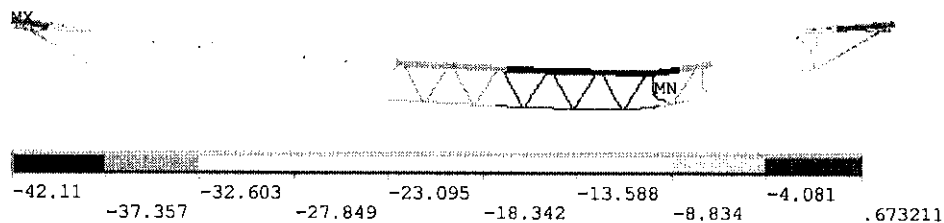
Figure 6-11. Vertical displacement at 700 °C.

- Single composite truss and concrete slab section. A floor section was modeled to investigate failure modes and sequences of failures under combined gravity and thermal loads. The floor section was heated to 700 °C (with a linear thermal gradient through the slab thickness from 700 °C to 300 °C at the top surface of the slab) over a period of 30 min. Initially the thermal expansion of the floor pushed the columns outward, but with increased temperatures, the floor sagged and the columns were pulled inward. Knuckle failure was found to occur mainly at the ends of the trusses and had little effect on the deflection of the floor system. Figure 6-11 shows that the diagonals at the core (right) end of the truss buckled and caused an increase in the floor system deflection, ultimately reaching approximately 42 in. Two possible failure modes were identified for the floor-truss section: sagging of the floor and loss of truss seat support.

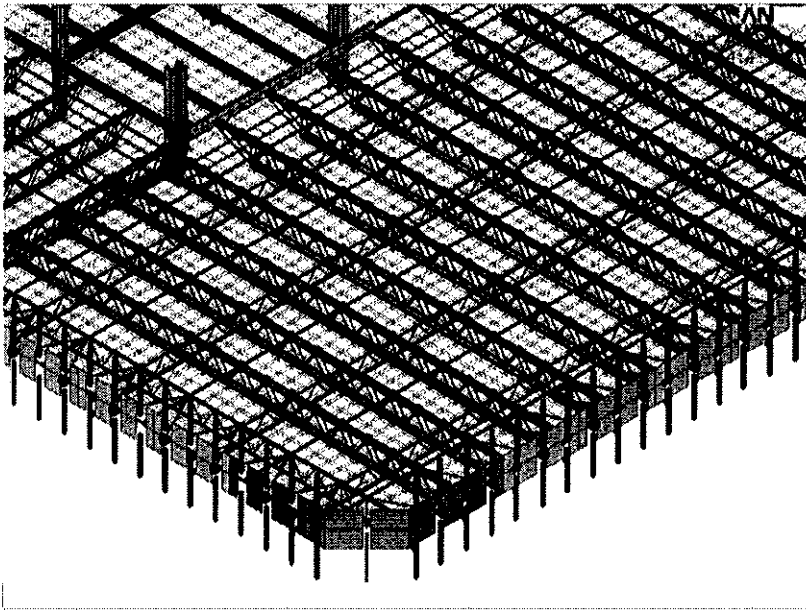
Figure 6–12. ANSYS model of 96th floor of WTC 1.

The model was used to evaluate structural response under dead and live loads and elevated temperatures, identify failure modes and associated temperatures and times to failure, and identify reductions in modeling complexity for global models and analyses. The structural response included thermal expansion of steel and concrete members, temperature-dependent properties of steel and concrete that affected material stiffness and strength, and bowing or buckling of structural members. The deformation and failure modes identified were floor sagging between truss supports, floor sagging resulting from failure of a seat at either end of the truss, and failure of the floor subsystem truss supports.
